## STRUCTURAL BEHAVIOR OF CIVIL ENGINEERING STRUCTURES: HIGHLIGHT IN HISTORICAL AND MASONRY STRUCTURES

Paulo B. Lourenço<sup>1</sup>

### Abstract

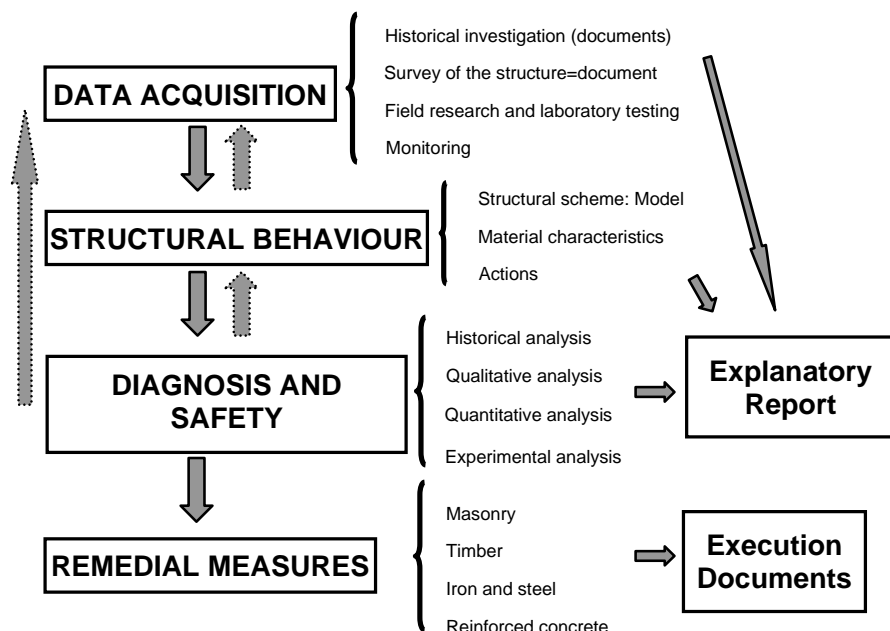
Figure 1 - Flowchart with the methodology for structural interventions<sup>2</sup>

The recommended methodology for completing a project is shown in Figure 1, where an iterative process is clearly required, between the tasks of data acquisition, structural behavior, and diagnosis and safety. In particular, diagnosis and safety evaluation of the structure are two consecutive and related stages on the basis of which the effective need for and extent of treatment measures are determined. If these stages are performed incorrectly, the resulting decisions will be arbitrary: poor judgment may result in either conservative and therefore heavy-handed conservation measures or inadequate safety levels. Evaluation of the safety of the building should be based on both qualitative (as documentation, observation, etc.) and quantitative (as experimental, mathematical, etc.) methods that take into account the effect of the phenomena on structural behavior. Any assessment of safety is seriously affected by the uncertainty attached to data (actions, resistance, deformations, etc.), laws, models, assumptions, etc. used in the research, and by the difficulty of representing real phenomena in a precise way.

The methodology stresses the importance of an “Explanatory Report”, where all the acquired information, the diagnosis, including the safety evaluation, and any decision to intervene should be fully detailed. This is essential for future analysis of continuous processes (such as decay processes or slow soil settlements), phenomena of cyclical nature (such as variation in temperature or moisture content) and even phenomena that can suddenly occur (such as earthquakes or hurricanes), and for future evaluation and understanding of the remedial measures adopted in the present.

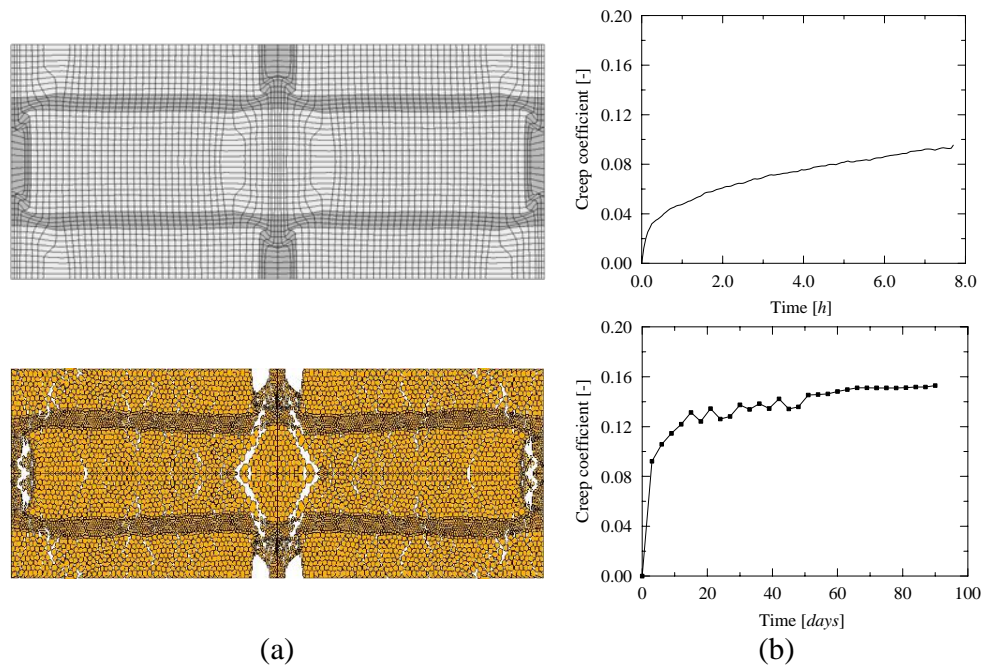
**Figure 2 - Masonry under compressive behavior<sup>9</sup>, (a) short-term and (b) long-term loading**

loading<sup>9</sup>, see also Figure 2. Figure 2a shows the simulation of a masonry representative volume under compression, with a continuum and particulate model. The differences found in terms of simulated compressive strength are up to 30%. Figure 2b shows a striking difference between strain rate values in short-term and long-term creep tests, meaning that the minimum duration of loading when conducting creep tests at high stress levels must be carefully selected.

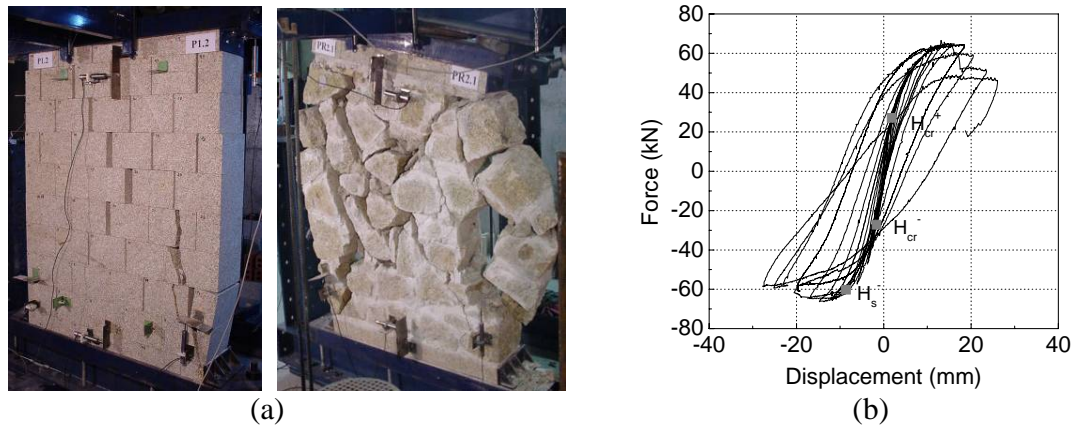
**Figure 3 - Behavior of stone masonry walls with different bond<sup>6</sup>: (a) failure modes and (b) selected force-displacement diagram.**

Scarce experimental information is available for stone masonry walls and a comprehensive testing program was started at University of Minho, aiming at increasing the insight about the behavior of typical ancient masonry walls under cyclic loading<sup>6</sup>. Besides the strength and stiffness characterization, information about nonlinear deformation capacity was obtained in terms of ductility factors and lateral drifts, which represents a step forward for the new concepts of performance based design. Regular and irregular stones have been adopted, see Figure 3. Although no significant differences were found in terms of strength and lateral stiffness among the distinct types of walls, low mortared strength masonry walls exhibit markedly higher level of energy dissipation when compared with dry stacked masonry.

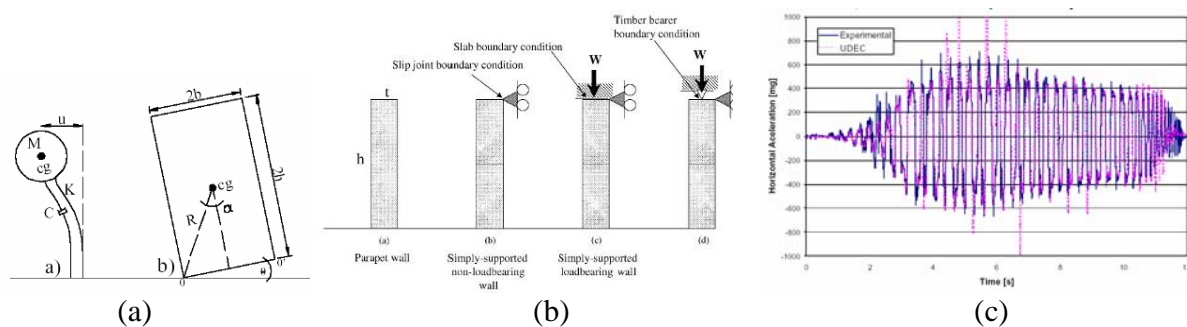
**Figure 4 - Dynamic behavior of blocky stone structures: (a) simplified models for analysis, (b) possible out-of-plane conditions for masonry walls, and (c) typical experimental / numerical results for hanning sinusoidal forced vibration**

The behavior of masonry can often be associated with dry blocky structures, which feature zero tensile strength in the joints but horizontal homogenized tensile strength and shear strength due to frictional effects. Limit analysis simulations are often used in practice for safety assessment and strengthening design. In order to extend limit analysis formulation to include dynamics and in order to study out of plane seismic behavior of masonry walls, another comprehensive testing program was set-up at University of Minho and National Laboratory of Civil Engineering (LNEC, Portugal). Figure 4 illustrates the details of the testing program, including simplified

analysis models, structures under analysis and results. Tests of single blocks, two blocks and a dolmen structure have been carried out<sup>10,11</sup>.

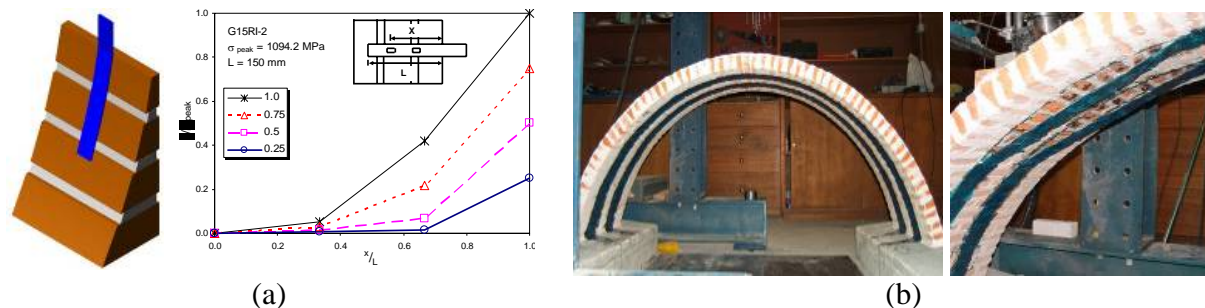
**Figure 5 – Traditional masonry strengthened with FRP: (a) bond tests with different masonry curvatures; (b) arch tests under point load**

Among the materials used to repair or upgrade civil engineering structures, there has been an increasing interest devoted to the use of FRP (fiber-reinforced polymer) composites in the form of bonded surface reinforcements. A set of eight arches, built with traditional low strength materials, have been tested under a monotonic vertical load applied at the quarter span, with different positions for the strengthening. In addition, also the bond between masonry and FRP have been characterized in a testing program being finalized, see Figure 5.

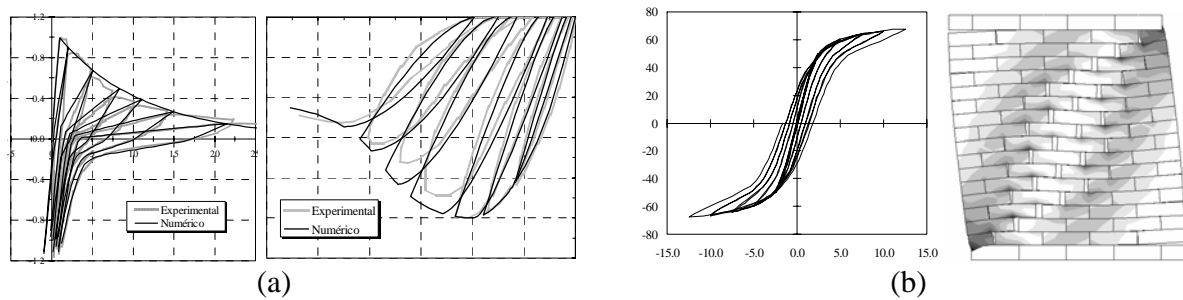
**Figure 6 – Behavior for an interface model extended to cyclic formulation: (a) tension-compression, (b) compression and (c) shear walls.**

A complete micro-model must include all the failure mechanisms of masonry, namely, cracking of joints, sliding over one head or bed joint, cracking of the units and crushing of masonry<sup>12</sup>. By adopting appropriate evolution rules in a finite element environment<sup>13</sup>, it is possible to reproduce non-linear behavior during unloading. Figure 6 shows the results of modeling a shear wall with an initial vertical pre-compression pressure. Figure 7 illustrates results using advanced solution procedures for non-linear optimization problems, with a limit analysis constitutive model that incorporates non-associated flow at the joints and a novel formulation for torsion<sup>14</sup>.

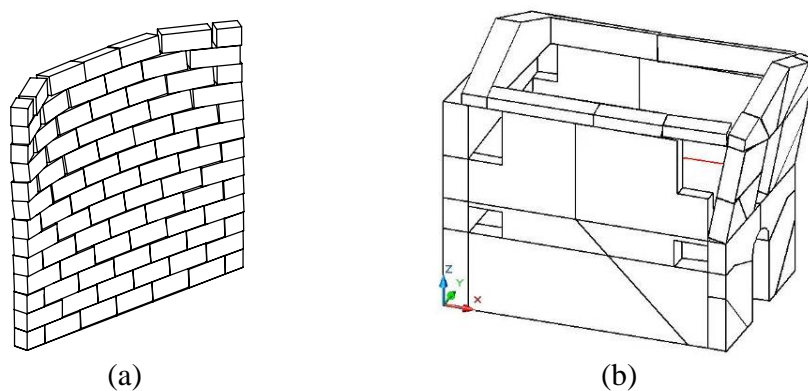
**Figure 7 – Results for rigid block limit analysis: (a) panel subjected to out-of-plane failure and (b) simplified analysis of a complete building with macro-blocks.**

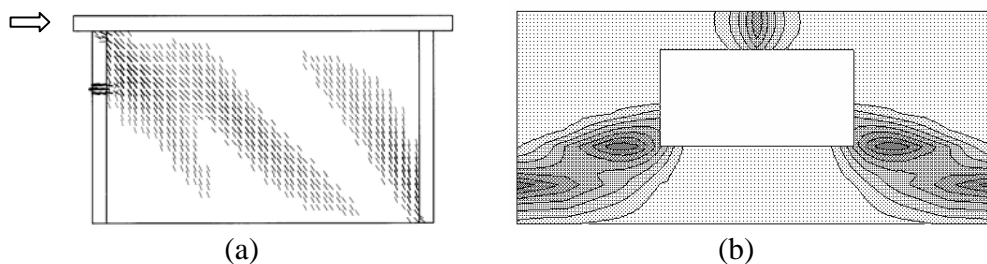
**Figure 8 – Results for macro-modeling analysis: (a) shear wall and (b) panel subjected to out-of-plane failure**

advantages of modern plasticity concepts with a powerful representation of anisotropic material behavior, which includes different hardening/softening behavior along each material axis. Figure 8 shows the results of modeling a shear wall with an initial vertical pre-compression pressure and a wall panel subjected to out of plane failure.

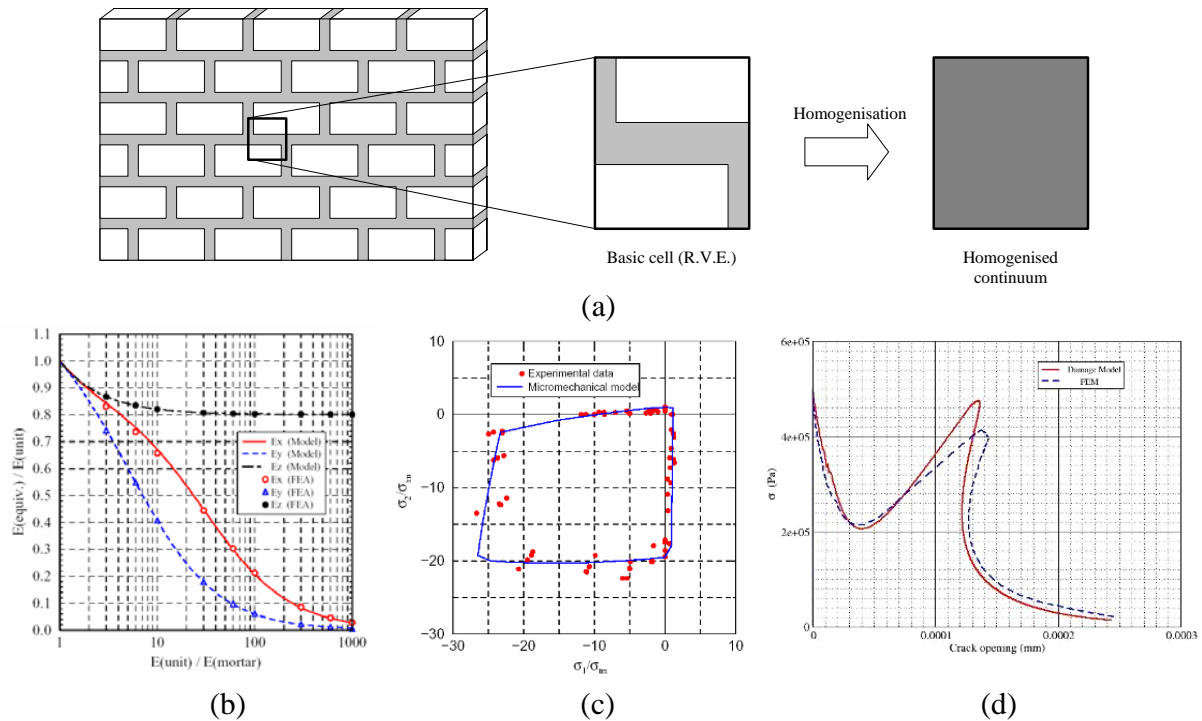
**Figure 9 – Results for homogenization (macro) analysis: (a) basic cell and process; (b) elastic homogenization; (c) failure surface; (d) constitutive behavior in tension.**

Another approach that is receiving much attention from researchers is the homogenization theory, in which the macro constitutive behavior of masonry is obtained from a mathematical process involving the geometry and the constitutive behavior of the masonry components. Figure

9 illustrates typical results obtained for homogenized failure surfaces and homogenized constitutive behavior<sup>16-18</sup>.

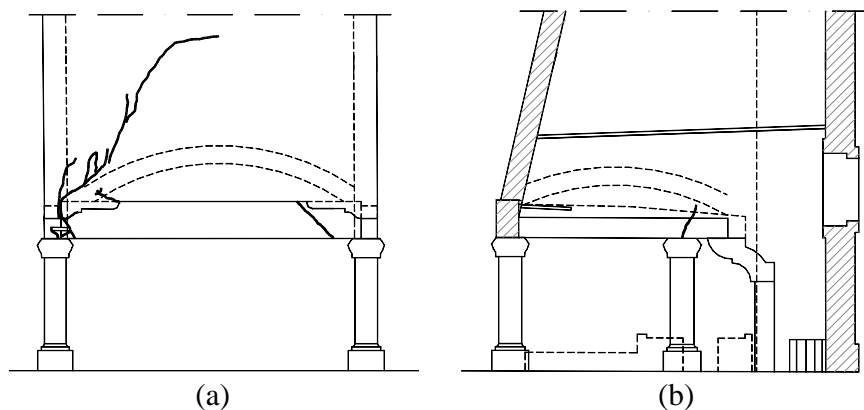
**Figure 10 – Observed cracking patterns: (a) main wall and (b) left side wall.**

The main damage exhibited by the chimney consists of a sudden diagonal crack, which appeared suddenly in the main lintel, close to the right support, and resulted in temporary propping of the structure, see Figure 10. This crack intercepts the anchoring zone of a  $45^\circ$  iron tie

(corroded) that connects the main lintel and the right lintel, which is a singular and weaker part of the lintel. The main lintel exhibits also several cracks close to the left support and in the vicinity of the iron cramp, which is severely corroded. In the masonry wall above the main lintel, a set of diagonal cracks is present. The inspection openings in the plaster indicate that the cracks do not intercept the hidden masonry arch, but they run through the arch extrados. An ancient crack is also present in the left side lintel and wall, probably due to the reduction of height of the stone lintel in the corbel region, as discussed above. As a result of this crack, two stone columns under each side lintel were added to the structure in an unknown date.

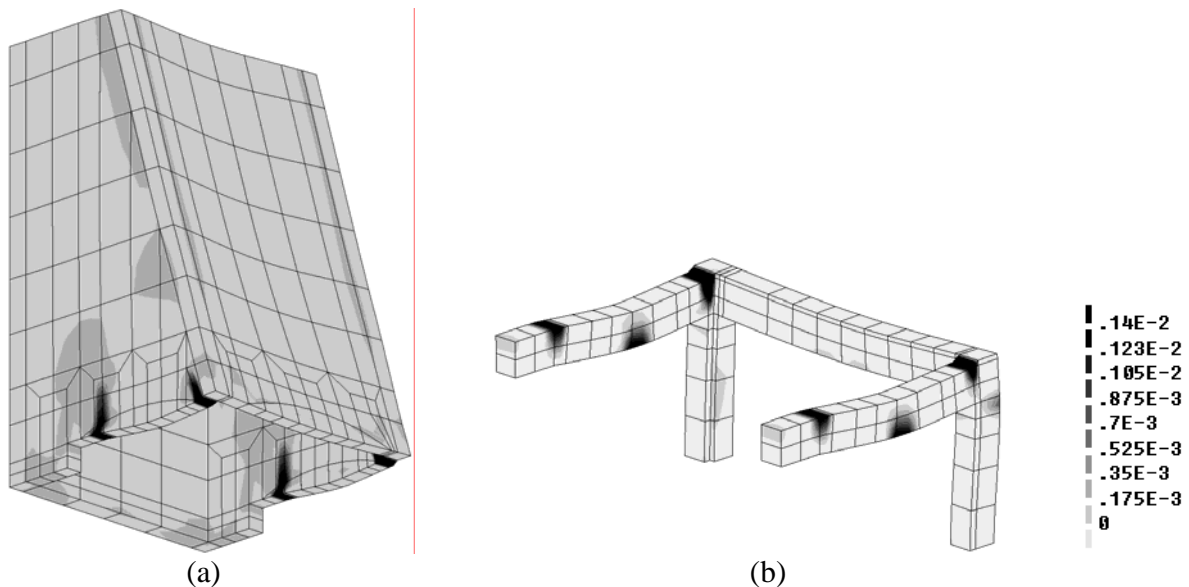
**Figure 11 – Maximum principal strains (cracks), plotted in the deformed mesh at collapse: (a) brick masonry part; stone columns and lintels. Results are dimensionless.**

In order to complete the diagnosis and safety evaluation, two three-dimensional models of the chimney were prepared aiming at simulating extreme possibilities, which take into account the fact that there is no separation between the arches and the material filling the space between the arches and the lintels. Here, only the model assuming that the walls are fully supported in the lintels is considered, being the most conservative approach. The model is made of quadratic solid finite elements (bricks and wedges), with approximately 500 elements and 3805 nodes, making a total of 11415 degrees of freedom. The constitutive models, material properties, loads and boundary conditions are detailed in <sup>19</sup>.

Structural collapse was found for a load factor of 2.0, where the load factor represents the ratio between the applied loads and the original reference loads. For the ultimate load factor, the most damaged zones in the masonry walls occur close to the supports of the side lintels and in the lintels-columns set, which clearly defines the collapse mechanism, see Figure 11. Three plastic hinges appeared in the side lintels, one hinge at mid-span with cracking at the lower face of the lintels (positive bending moments), and two hinges at the supports with cracking at the upper face of the lintels (negative bending moments).

The results of the structural analysis clearly indicate that the sudden collapse of the main lintel is not due to structural reasons, being probably triggered by corrosion of the tie that connects the main lintel and the right side lintel (here, it is noted that the environment is aggressive due to rising damp, salt and organic materials from the old kitchen activity). Certainly the local discontinuity associated with the hole for anchoring the iron tie also contributes to weaken the main lintel. The structural analysis results justify the ancient damage in the left side lintel. In fact, the numerical simulation does not take into account the cross section reduction in the left side lintel (the height varies linearly from 0.46 m to 0.30 m), which would reduce the safety

factor significantly. This justifies the remedial measures adopted in the past by adding new stone columns close to the back supports of the side lintels.

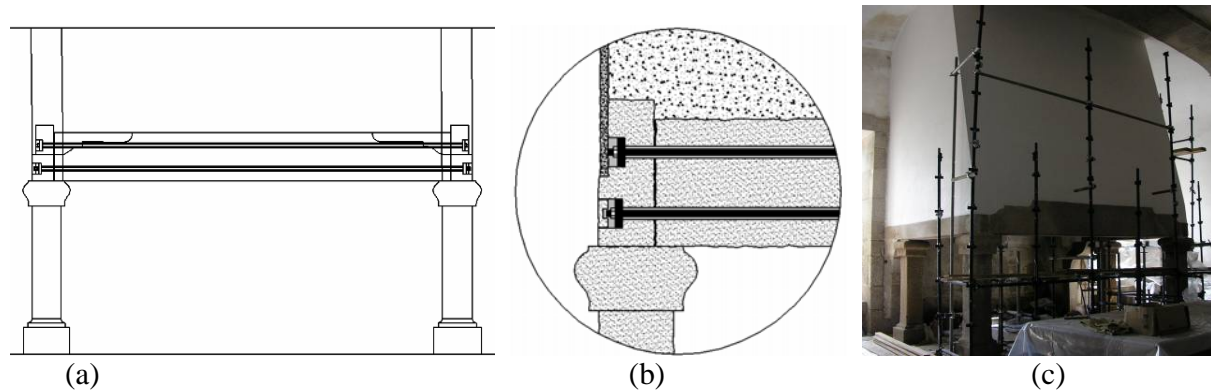
**Figure 12 – Strengthening: (a) front view; (b) detail of anchoring zone; (c) final aspect.**

The observed damage requires structural strengthening, which is complex due to the geometry of the column capitals and the fact that stone granite is a facing material. This means that any strengthening applied externally would become visible and would be aesthetically rather unappealing. The other preliminary issue discussed with the client was the issue of removing or keeping the two additional stone columns installed as a previous remedial measure (date unknown but before the 20<sup>th</sup> century). Conservation principles are often used as an absolute prohibition against the removal of earlier repair work. But often it is possible to find examples of repairs that do not constitute a valid part of the history of the structure. In the present case, it is believed that the additional columns can indeed be removed from historical reasons but the additional complexity and costs to further strengthen the chimney advise not to take this action.

The final solution consists of strengthening and repairing the main lintel including: (a) reconstitution of the original stone integrity by injection of epoxy resins; (b) hole drilling of the stone along its full length (4.70 m); (c) insertion of bars and injection of the hole. Figure 12 illustrates various details of the solution, which includes two stainless steel rods with a diameter of 25 mm as internal ties / reinforcement of the granite lintel. The ties were designed after the integration of the tensile stresses of the linear elastic results for the numerical model without arching action, which is conservative. These rods are inserted in drilled holes of 50 mm and are provided with anchoring plates of 120 mm. After adjustment of the bolts, the drilled holes are injected with fluid lime mortar. Stone stoppers at both ends of the bottom tie are also included so that the anchoring plates are not visible. The stoppers are glued with epoxy resin and are made from the actual core removed from the lintel. It is noted that the usage of stone stoppers in both ends of the ties requires the drilling to be executed from both sides, which requires precision and qualified workers.

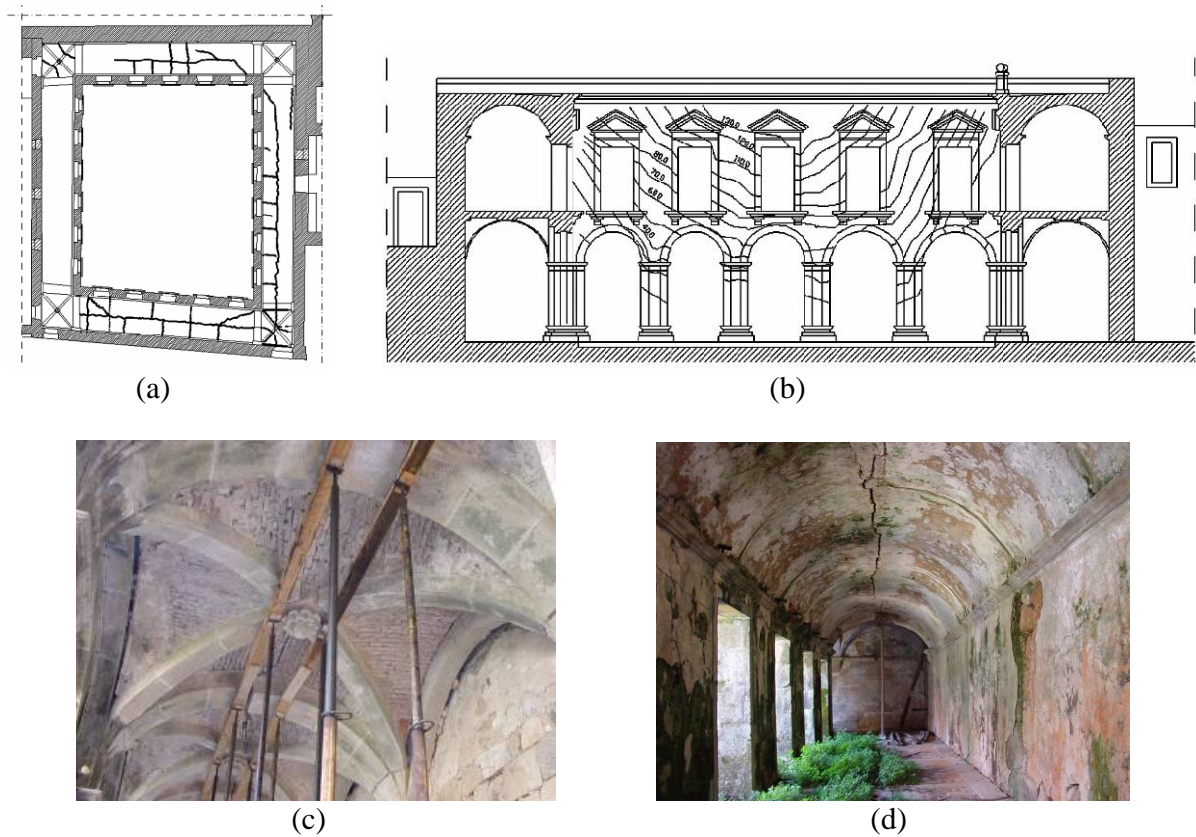
**Figure 13 – Damage in the Salzedas' cloister: (a) mapping of cracks (2<sup>nd</sup> level); (b) out-of-plane displacements; (c) aspect of vault (1<sup>st</sup> level); (d) aspect of vault (2<sup>nd</sup> level).**

The condition of this cloister is quite poor, including biological colonization sometimes associated with moisture stains, deterioration of the bricks in the vaults, cracks with variable thickness, crushing of stones and excessive movements in walls and vaults<sup>20</sup>. The largest and widest set of cracks occurs in the barrel vaults of the 2<sup>nd</sup> level, as well as in two corners. The cracks occur mostly in the longitudinal direction, even if some transversal cracks also occur, up to a crack opening of 40 mm. The vaults of the first level exhibit also cracks, up to a crack opening of 15 mm. One wing is supported on temporary wooden poles. The walls exhibit widespread cracking at the 2<sup>nd</sup> level and almost no cracking at the 1<sup>st</sup> level. Vertical displacements up to 35 mm were measured at the key of the crossed vaults of the 1<sup>st</sup> level. But all the walls of the cloisters exhibit large horizontal movements that lead to the separation between the vaults and the walls, in a clear lack of verticality. The out-of-plumb displacement of the internal walls reaches values of up to 0.18 m. Several brackets supporting the crossed vaults of the first level show signs of compressive crushing. Also, a significant number of bricks show deterioration, particularly around the cracked areas. Figure 13 and Figure 14 detail typical observed damage.

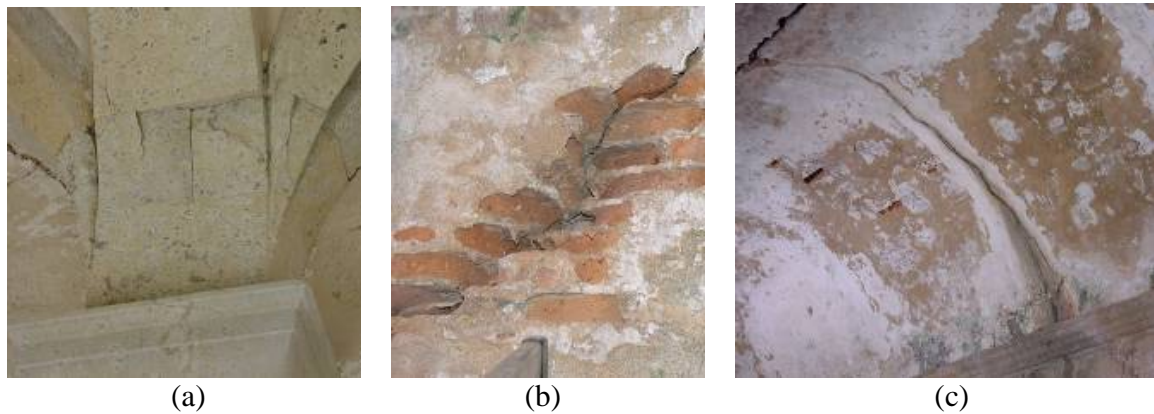
**Figure 14 – Damage in the Salzedas' cloister: (a) crushing of brackets; (b) deterioration of brick; (c) moisture stains and biological colonization.**

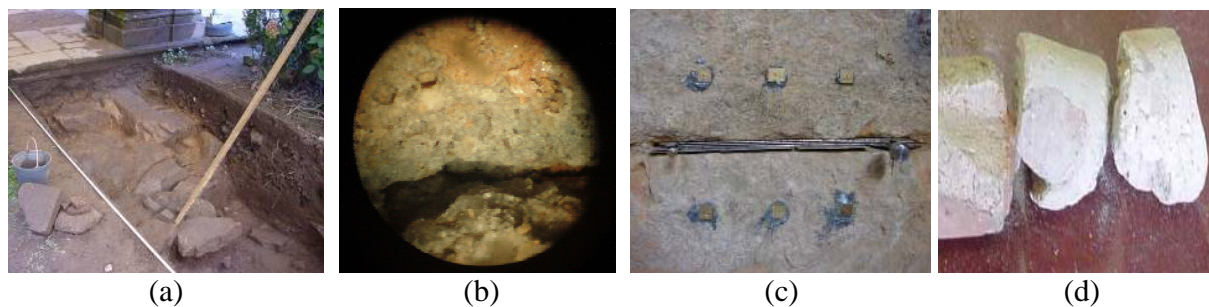
**Figure 15 – Inspection and diagnosis: (a) foundation pits; (b) boroscopic observations; (c) flat-jack testing; (d) coring.**

In order to characterize the cloister, to justify the observed damage and to define corrective measures, an experimental in-situ and laboratory testing program was carried out. This included a soil and foundation survey, visual inspection with the aid of an endoscope, flat-jack testing, coring, and chemical, physical and mechanical characterization of materials, see Figure 15. A numerical analysis of the structure allowed to discuss its safety and to better understand the causes of damage. The conclusions of the study were that: (a) the non-symmetry between the internal and external walls of the cloister result in movements in the direction of the court, as observed in the construction; (b) a linear elastic analysis of the construction results in very limited displacements (in the order of the millimeter) and moderate stress values (maximum tensile stress of  $+0.25 \text{ N/mm}^2$  and maximum compressive stress of  $-0.6 \text{ N/mm}^2$ ). The large displacements observed in the construction require a geometrical and physical non-linear analysis; (c) in order to obtain horizontal displacements in the order of the observed in the structure, it is necessary to consider the soil-structure interaction. It seems therefore that the foundations play a key-role in the observed damage; (d) the high movements recorded in the construction and the deterioration of the brick vaults indicate that the safety level of the structure is not compatible with any use and remedial measures are necessary, see Figure 16.

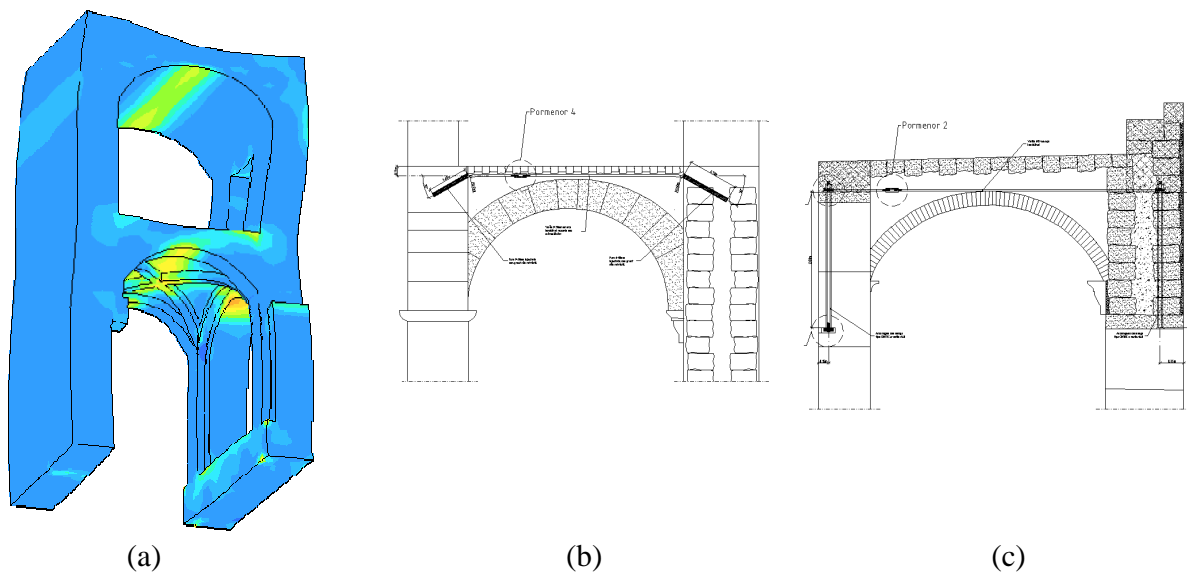
**Figure 16 – Remedial measures: (a) safety assessment; (b) 1<sup>st</sup> level tying; (c) 2<sup>nd</sup> level tying and stitching.**
